ABA BISC Meeting Baltimore, Maryland NTSB Update

Pala Mesa, CA

February 22, 2020

The Crash

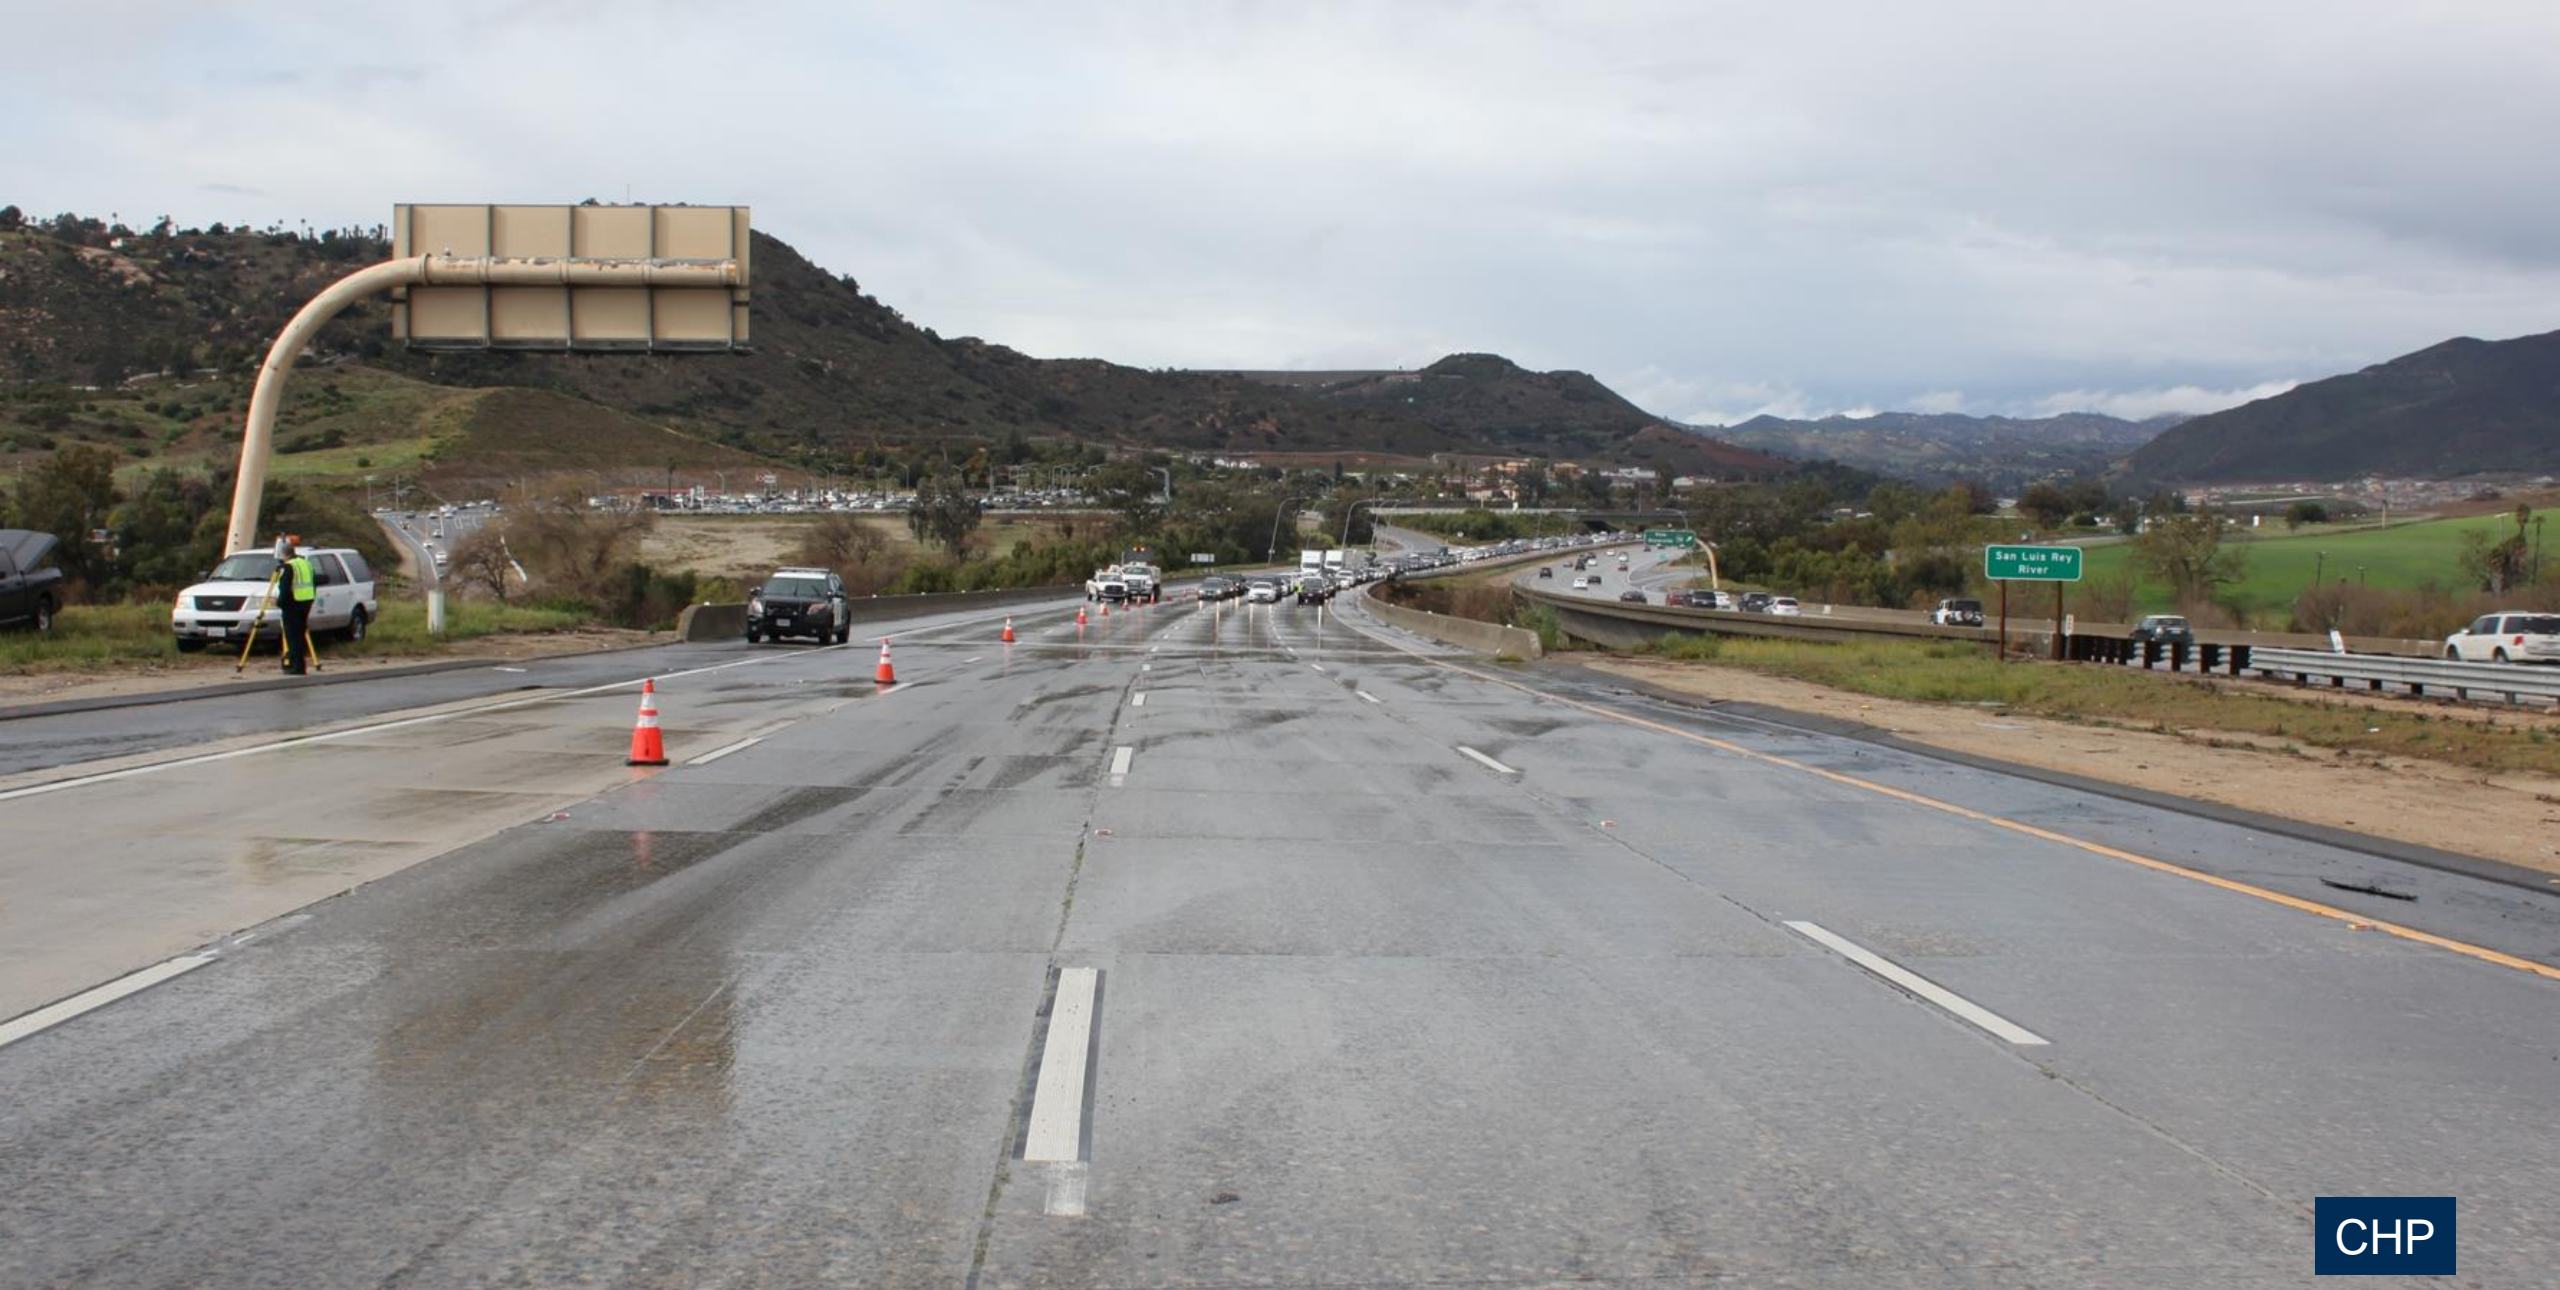
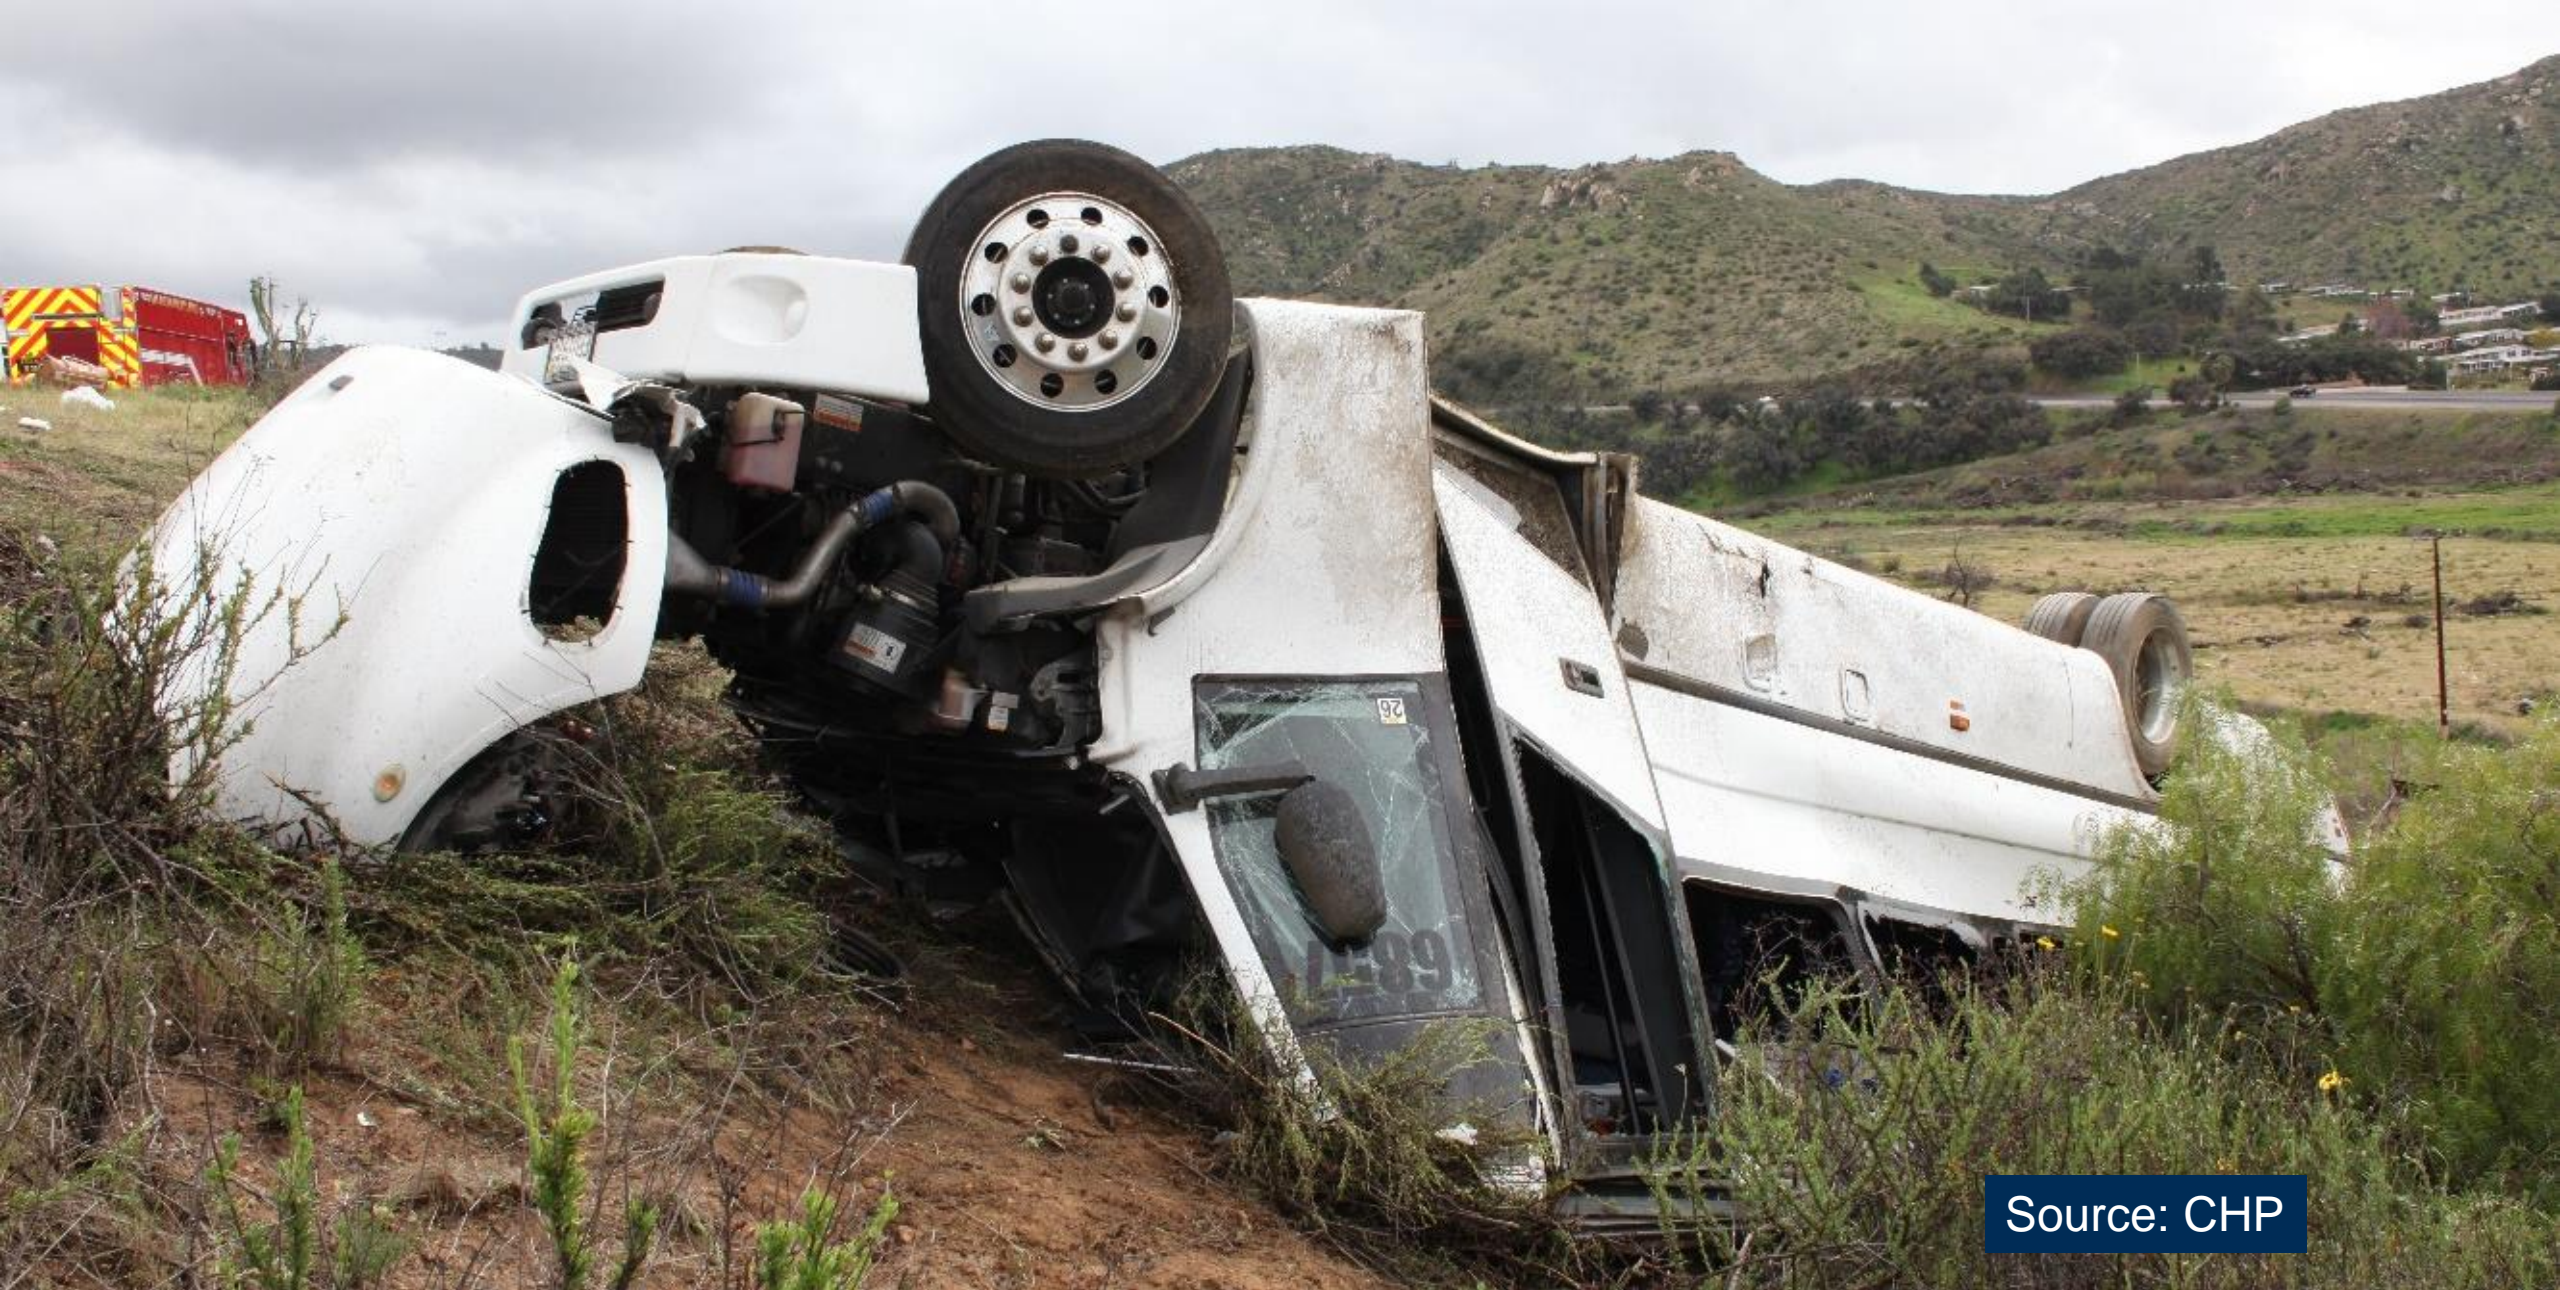
- Driver and 20 passengers on bus after Temecula stop
- About 10:23 a.m.
- Driver lost control
- Bus departed roadway to the right, rolled 1.5 times, came to rest on roof
- Data shows about 74 mph, sustained braking, sharp steering to the right
- Reports of moderate rain and wet roadway at the time

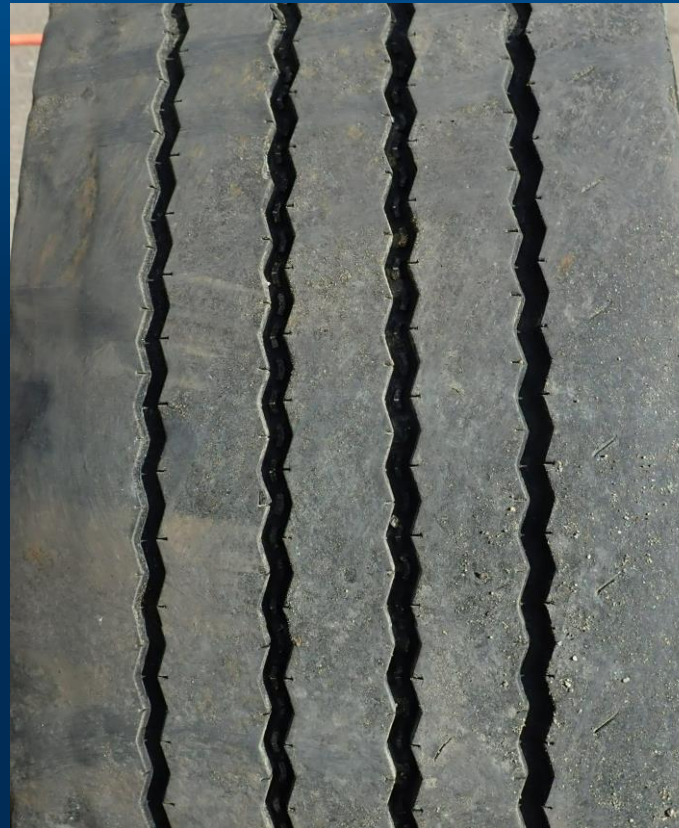
Steer Tire

Axle	Postcrash Bus Tread	
	Left	Right
Steer	10/32 nd inch	11/32 nd inch
Rear/Drive	1/32 nd inch (inside dual)	1/32 nd inch (inside dual)

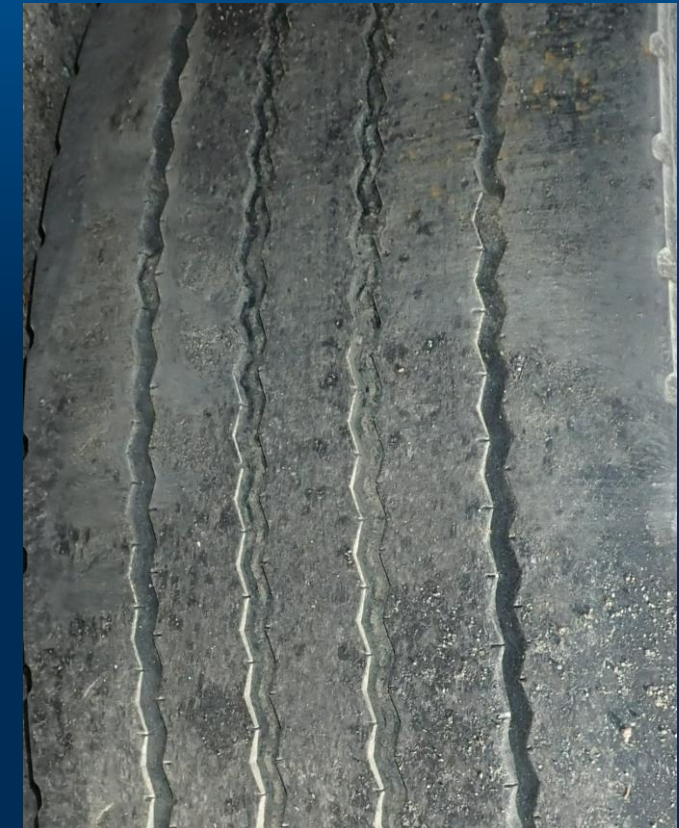
Inside Dual Tire

- Executive deficiencies in tire replacement and rotation practice allowed the bus to operate with tires with less than required tread depth
- The practice of replacing rear axle tires with used tires from steer axle can result in non-uniform tread depths, leading to loss of traction
- What we propose:
- One Recommendation to American Bus Association and the United Motorcoach Association
