ABA BISC Meeting Baltimore, Maryland NTSB Update

Pala Mesa, CA

February 22, 2020

The Crash

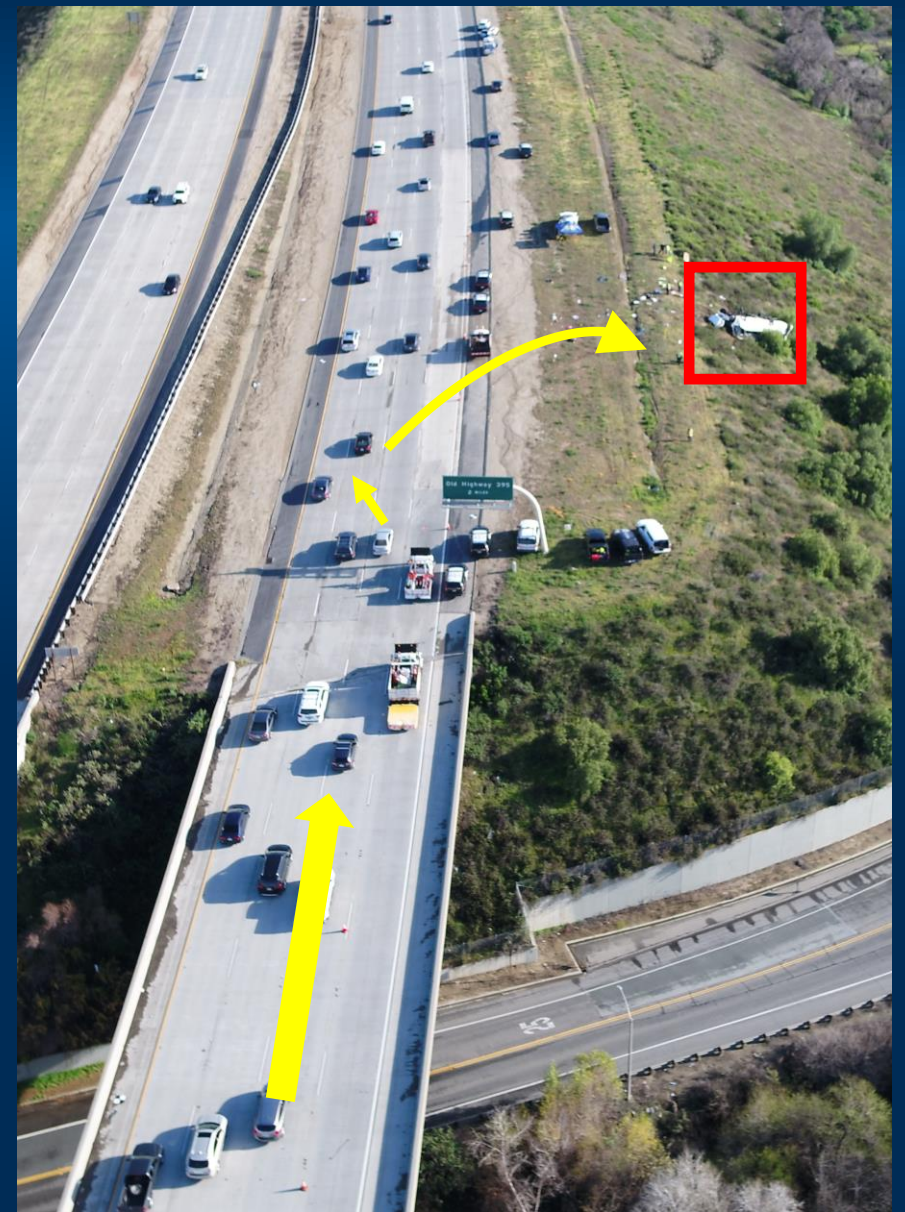
- Driver and 20 passengers on bus after Temecula stop
- About 10:23 a.m.
- Driver lost control
- Bus departed roadway to the right, rolled 1.5 times, came to rest on roof
- Data shows about 74 mph, sustained braking, sharp steering to the right
- Reports of moderate rain and wet roadway at the time

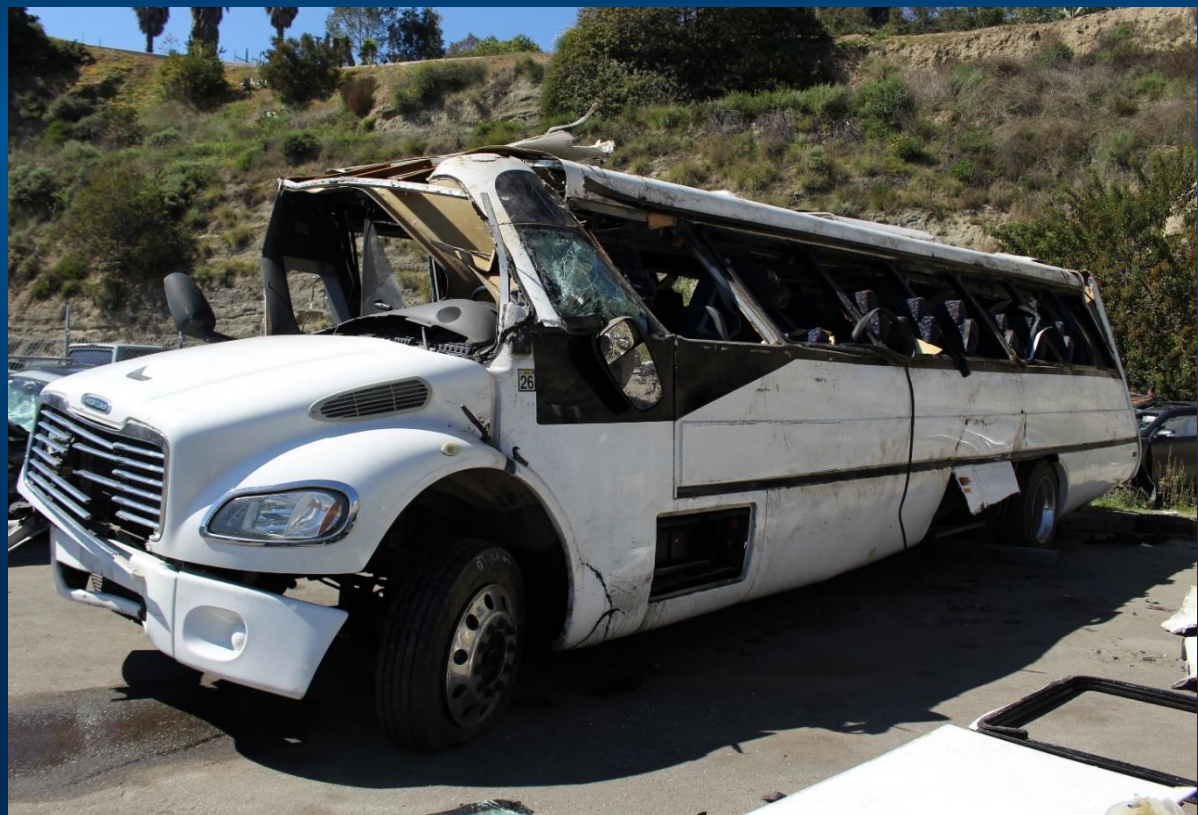
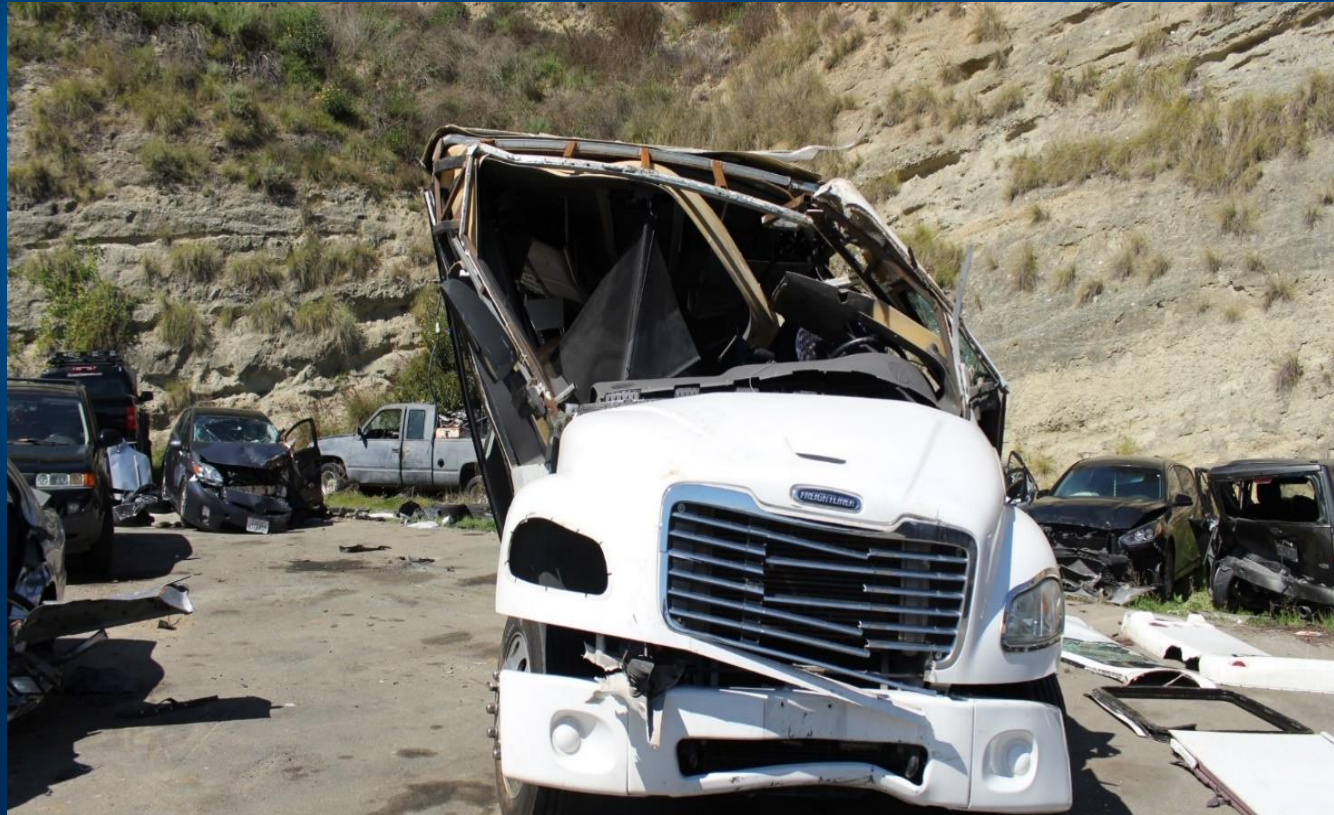
Bus Tire Tread Condition

Axle	Regulatory Minimum Tread	Postcrash Bus Tread (Left)	Postcrash Bus Tread (Right)
Steer	4/32 nd inch	10/32 nd inch	11/32 nd inch
Rear/Drive	2/32 nd inch	1/32 nd inch (inside dual)	1/32 nd inch (inside dual)

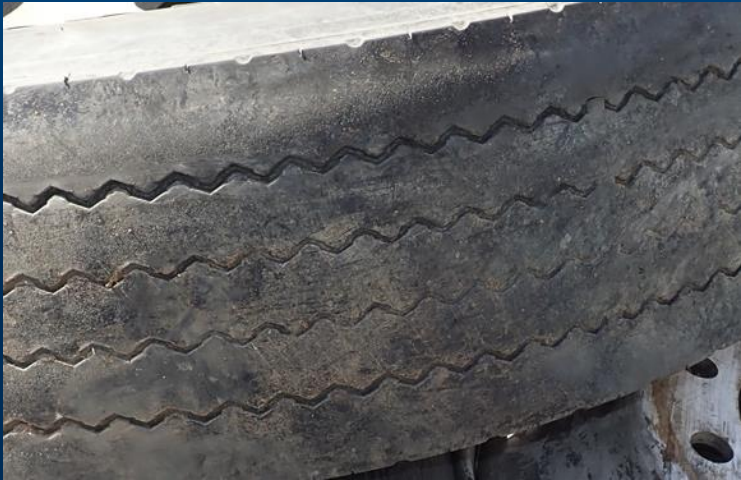
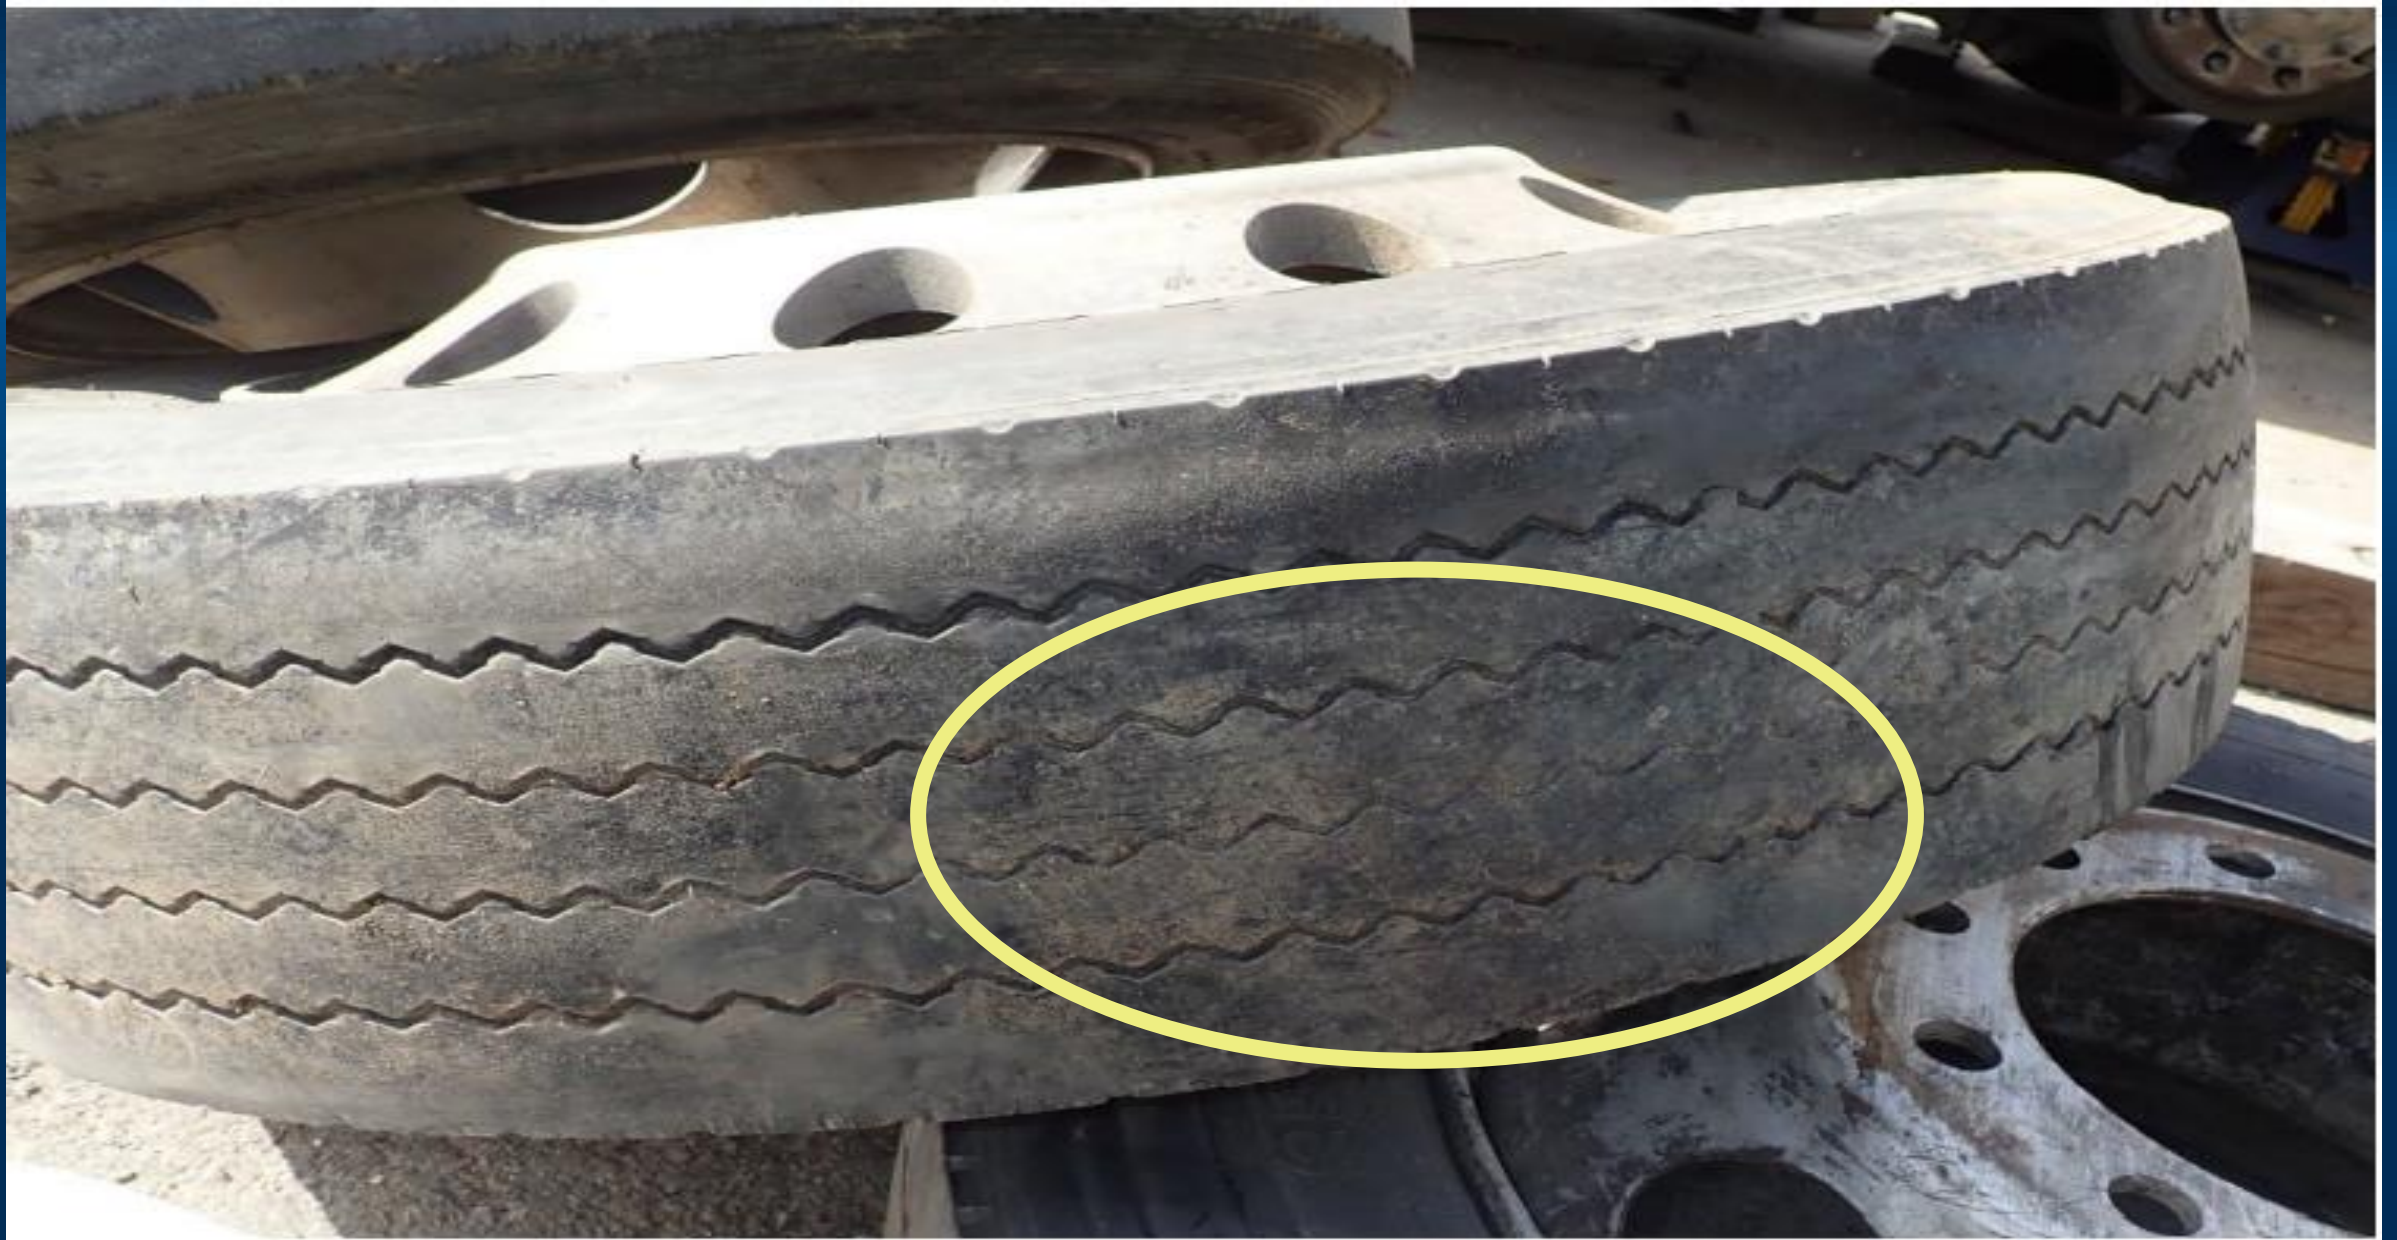
Bus Tire Tread Condition

Axle	Postcrash Bus Tread	
	Left	Right
Steer	10/32 nd inch	11/32 nd inch
Rear/Drive	1/32 nd inch (inside dual)	1/32 nd inch (inside dual)
